**READING BOROUGH  
COUNCIL**

Arthur Hill Baths

Condition survey

13<sup>th</sup> April 2015

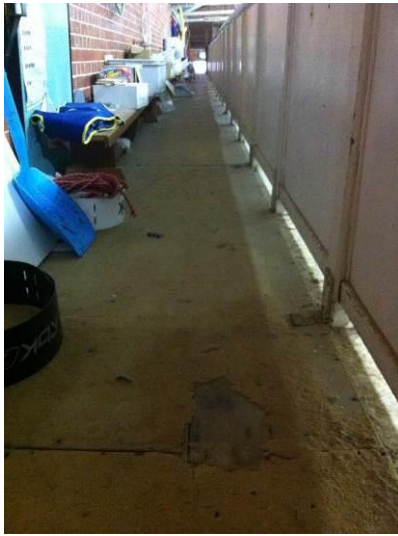
Floor covering to gallery on poolside

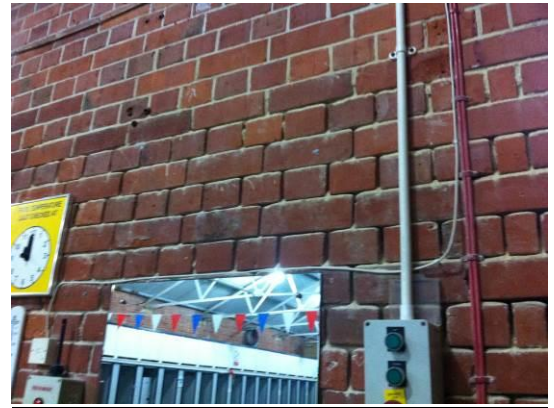
Eroded pointing within pool hall

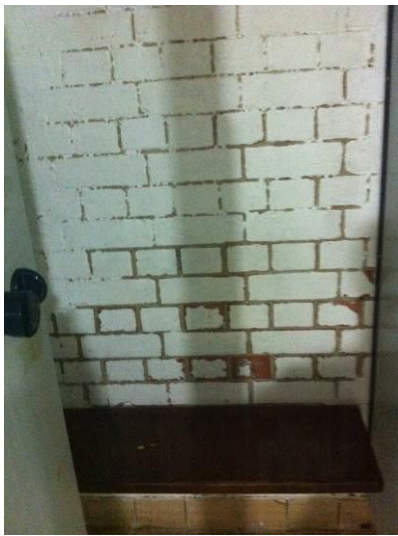
Eroded pointing to changing cubicles

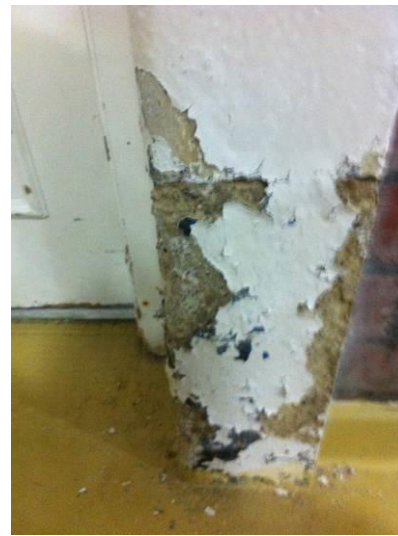
Deteriorated render to column in pool hall

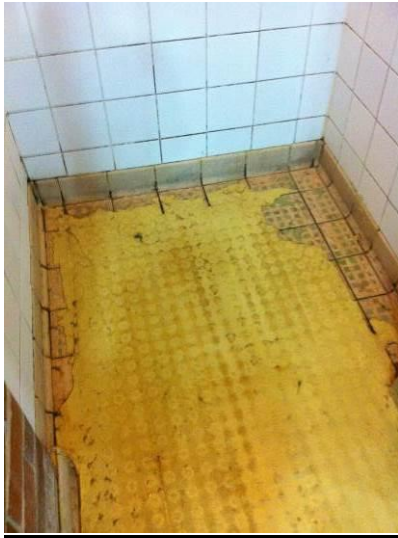
The flooring around the pool has a quarry tile finish. This has been coated within the past year using a non slip applied coating. Whilst generally this has worn well, there are areas, particularly to the shower and toilet areas where the coating has failed and should be reapplied.

Eroded waterproof coating to shower area

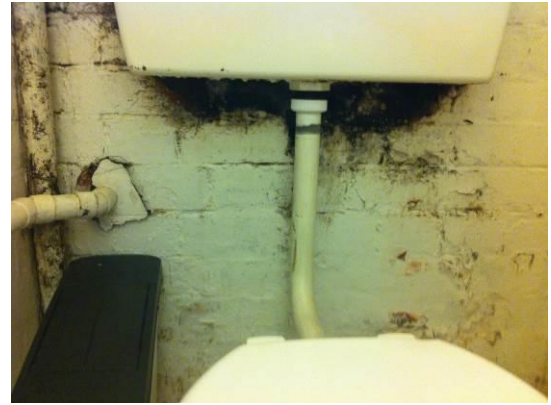
The walls are of solid construction with a painted brickwork finish. The paint finish is in poor condition with peeling paint and extensive mould growth was noted around the female WC cistern, and to the side of the Male WC. The mould growth around the cisterns is related to the humid atmosphere condensing on the cold water cistern. The mould should be cleaned off regularly, consideration should be given to using a mould inhibiting paint in these areas.

Mould growth under toilet cistern

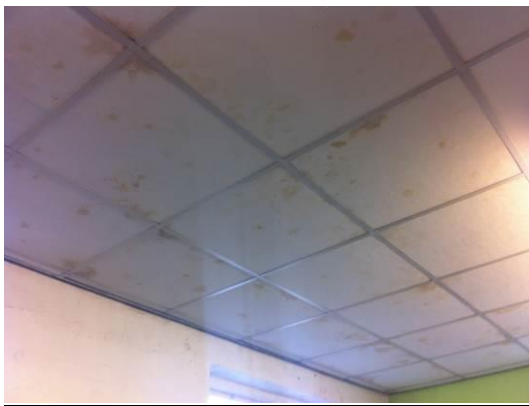
There is a 600mm x 600mm suspended ceiling grid with mineral tiles. The ceiling is dated and in relatively poor condition with staining indicating roof leaks and also various tiles sagging, lifting and faces peeling off. The ceiling tiles should be replaced, although the grid can be retained.

Water stained ceiling to gym

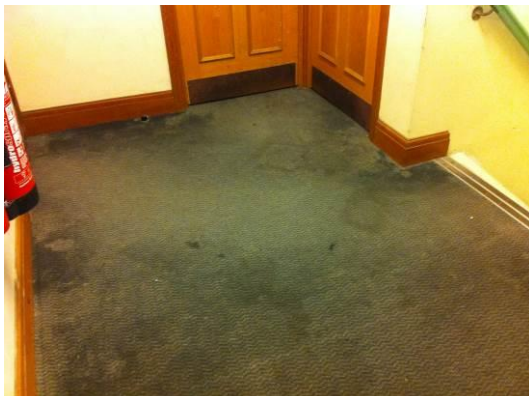
The stairs are in satisfactory condition, the carpet to the first floor is very dated and stained. This should be replaced.

Stained carpet to first floor

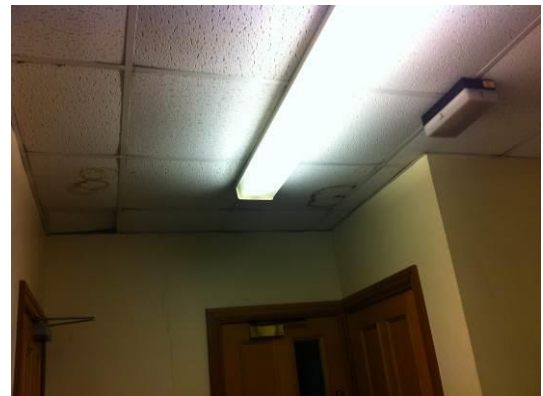
There is a mix of ceilings to the stairs, with a textured coating to the ground floor and a suspended ceiling to the first floor. Both are in satisfactory condition, although the textured coating requires redecorating. Evidence of water leaks were apparent to the suspended ceiling.

Water stained ceiling to first floor

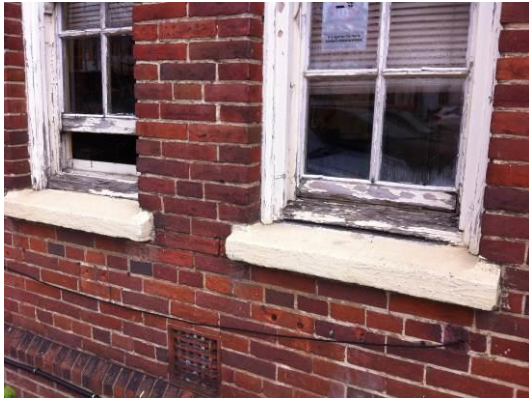
Windows to the front elevation are timber single glazed sliding sash windows with stone cills. These appear to be original to the building and are in poor decorative condition with areas of timber decay. Repair work and redecoration is required to all windows to prevent ongoing deterioration.

Timber windows to front elevation

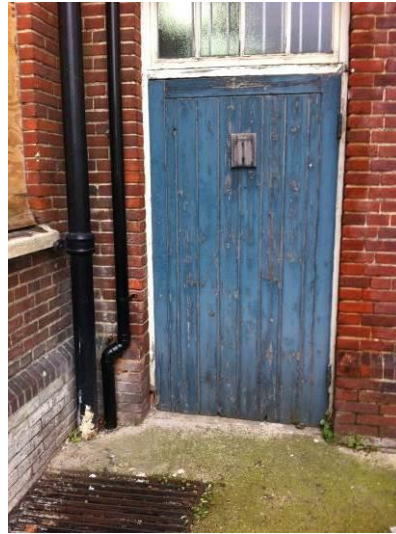
Fire doors to the front elevation are painted timber. These should all be redecorated to prevent timber decay and deterioration. The fire door to the LHS of the front elevation should be replaced, as there is extensive timber decay at the bottom.

Typical fire exit door to pool

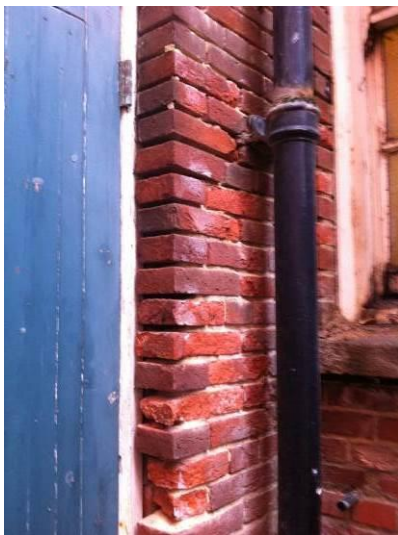
The brick reveal to the LHS fire exit door on the front elevation was badly eroded with mortar missing to the depth of the brickwork. This reveal should be rebuilt completely with new bricks.

Eroded brickwork around pool fire exit

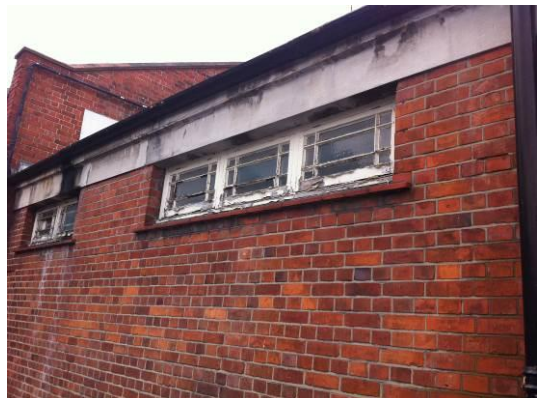
The rainwater goods to the rear and side elevations are PVC, these should be realigned to prevent water leaks down the face of the brickwork. Evidence was noted of leaking gutters to the side elevations.

Side elevation windows and leaking rainwater goods

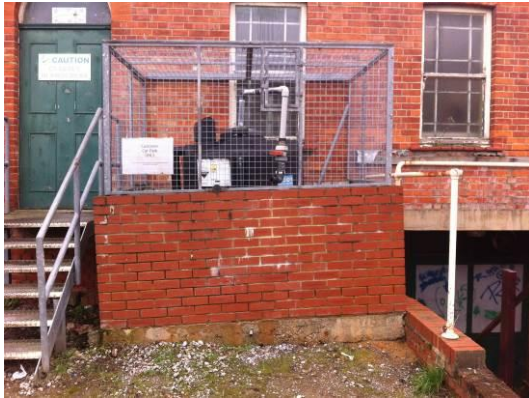
Chemical store bund

We noted no evidence to indicate progress differential foundation movement, with the exception of the rear chemical store which clearly has suffered subsidence.

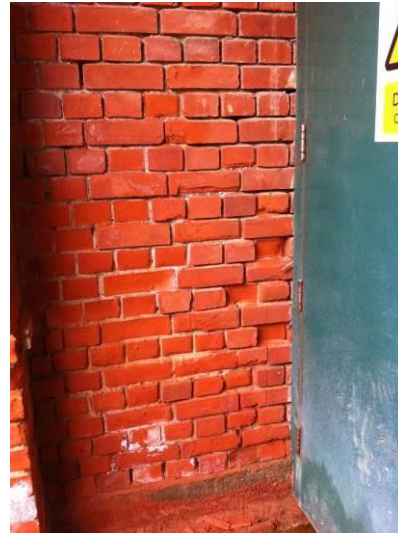
Eroded brickwork to basement

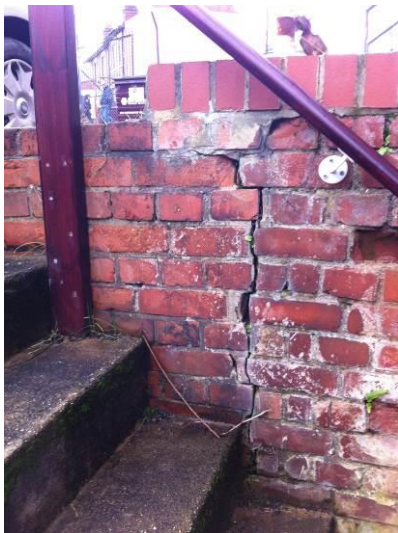
Two significant vertical cracks were present in the brickwork walls to the steps leading down to the rear plant room. These should be monitored for continued movement. They would indicate settlement under the building, which may be historic.

Crack to basement steps

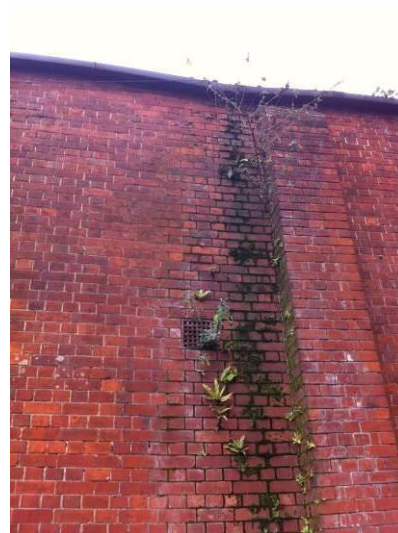
Leaking rainwater gutter

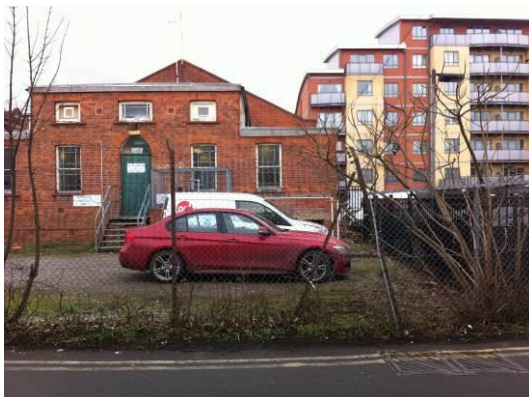
The chainlink fencing to the rear boundary should be refixed, an area has become loose and is leaning over.

Chainlink fence to rear

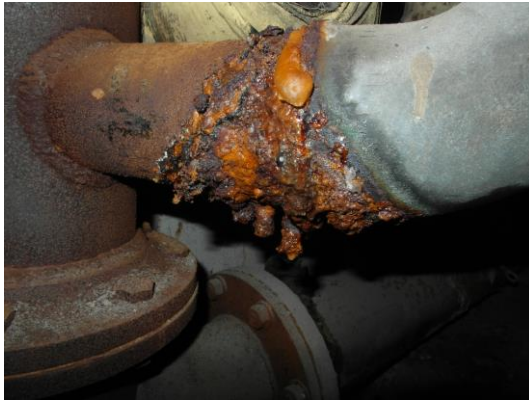
Excessive corrosion was observed to the main water inlet pipework within the pool plant room that poses a potential flood risk. Prompt maintenance is required to replace the section of pipework.

Corroded water pipe to pool
